CONSULTING ARBORIST TREE REMOVAL PERMIT REVIEW CHECKLIST

Permit Number: TRE14-05023

Re: Tree Removal Permit Application
Madison House
12215 NE 128th St
Kirkland, WA 98034

TO: Ron Hastie
JOB SITE: 12215 NE 128th St.
SUBJECT: Madison House Tree Inventory and Report
DATE: July 16, 2014
PREPARED BY: Chris Madison
ISA Certified Arborist PN-7671A
ISA Qualified Tree Risk Assessor

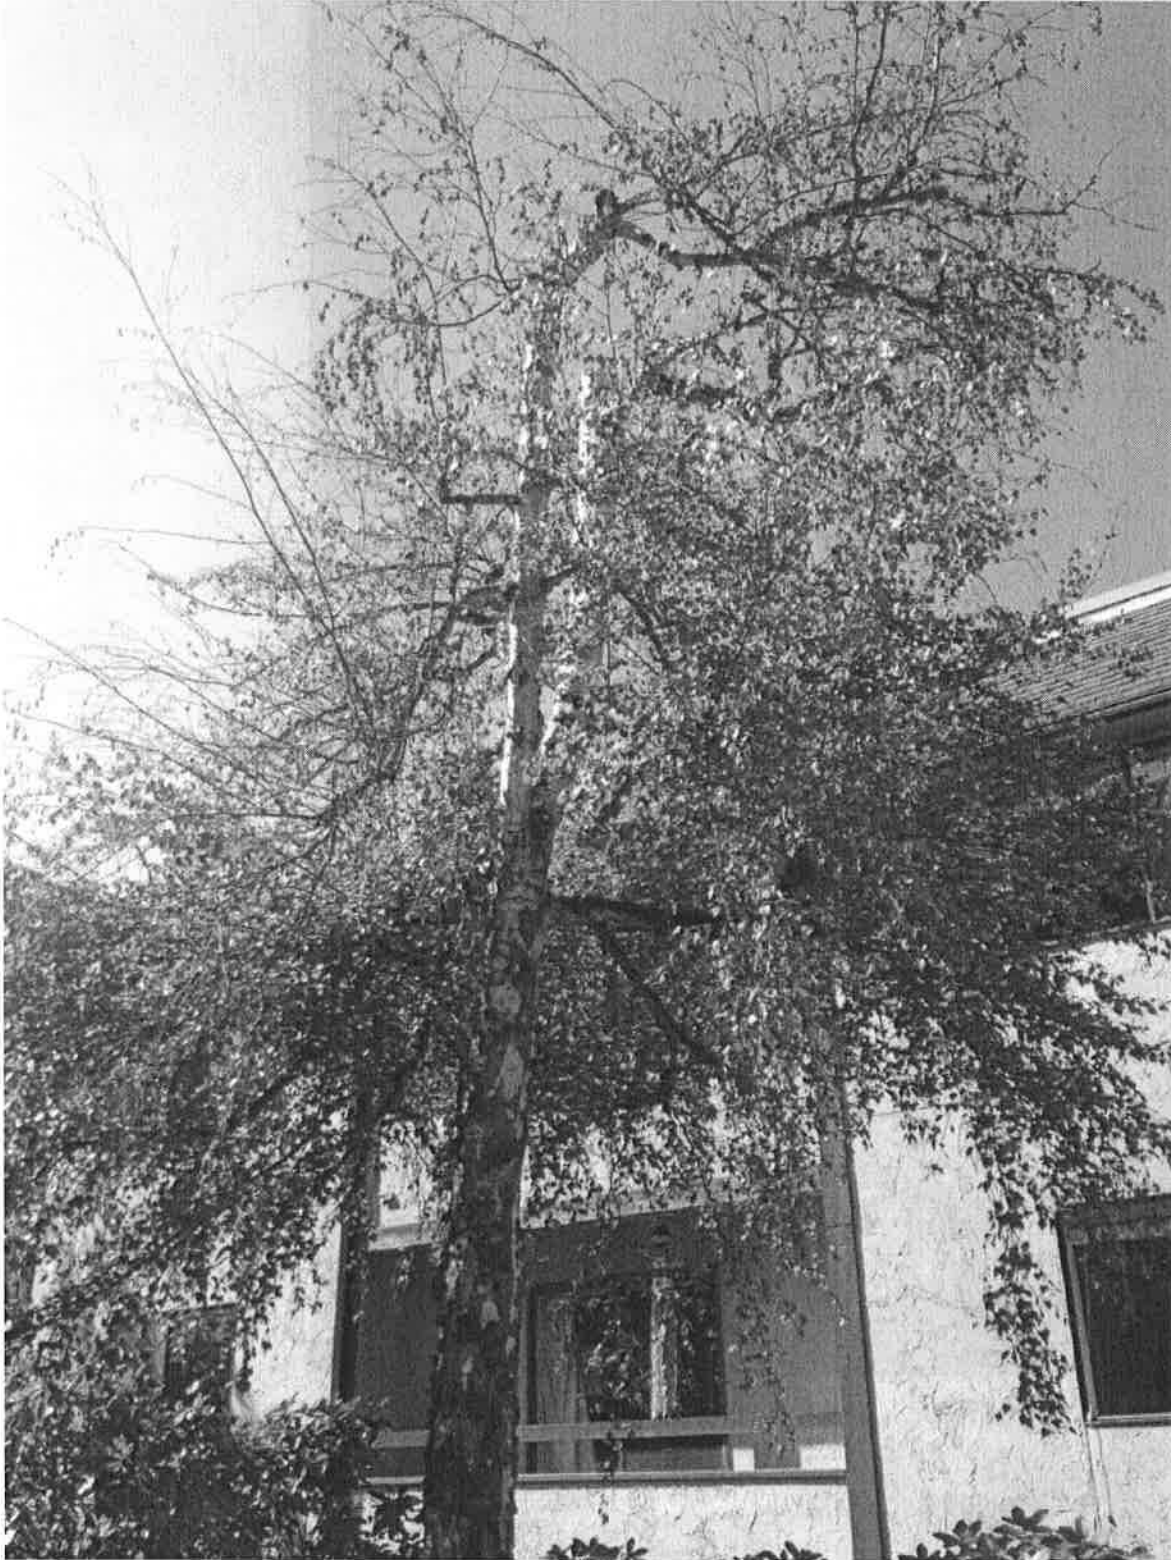
Typical birch at site, which shows die-back caused by bronze birch borer

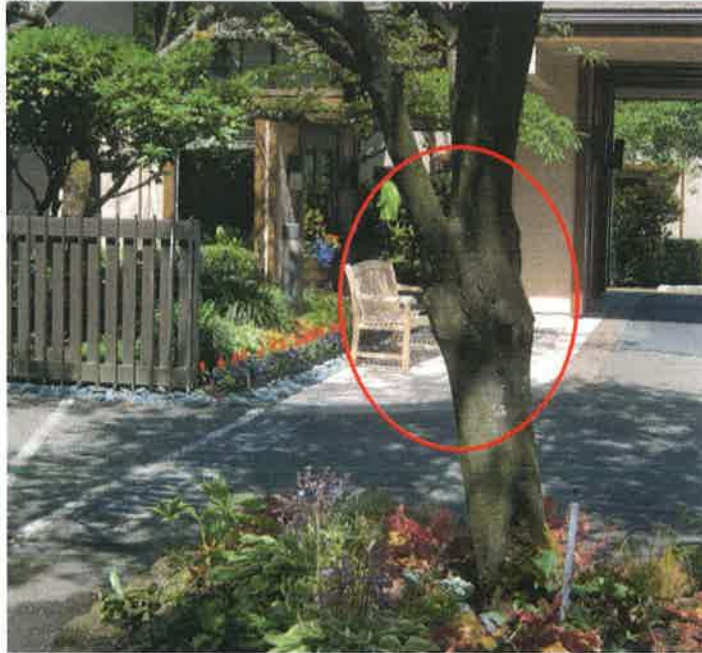
Tree 3 is a Flowering plum measuring 8.9 inches DSH. This tree has multiple branch attachments at a single union, with narrow angles of attachment. This form is also seen in Trees 20 and 24- both flowering plums. It's most likely these trees were formed pruned this way by the nursery. While this form is typical to this tree, it's not a structurally strong form which is why I gave this tree a fair structural rating (see [Photo 2](#)).

Photo 1- Tree 3. Note the close angle of attachments.

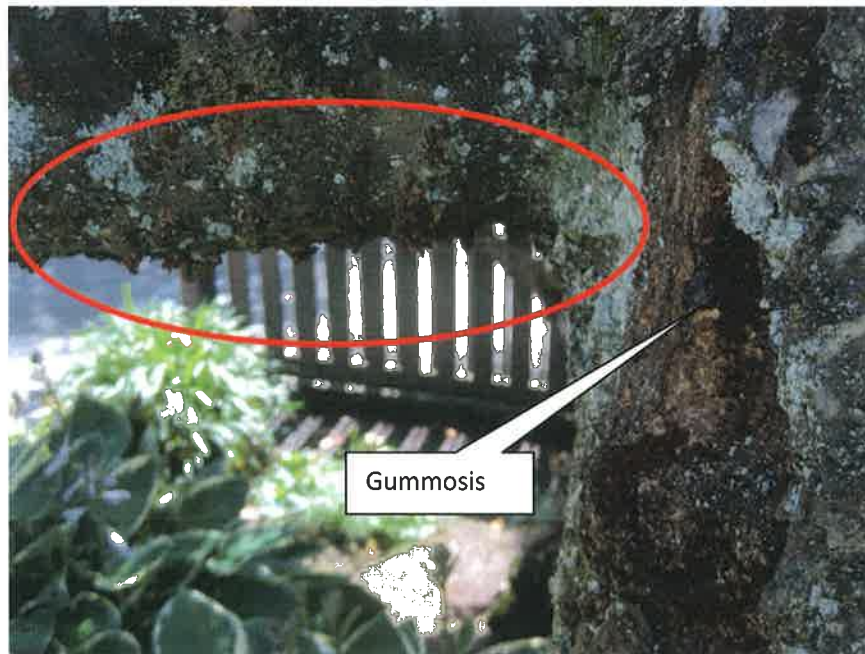
Many of the trees are flowering cherry trees, showed significant dieback in their canopy. During my visit I noted signs of Cherry bark tortrix (*Enarmonia formosana*) on many of the trees (see [Photo 1](#)). Cherry bark tortrix (CBT) is a moth whose larval form eats away at the vascular tissues of the plant, which cause branch dieback and eventual death of the entire tree if infestations are heavy enough. Branches which have died back do not recover, and pose a potential hazard to nearby targets. CBT is attracted to trees with fresh wounds on it, including pruning wounds. If trees were pruned during the time that adults are active (May through September) then infestation could have occurred.

Photo 2- Evidence of Cherry bark tortrix on Tree 5. Note the orange colored frass tubes hanging from the tree branch. Also note the gummosis, a response *Prunus* sp. give in attempt to ward off CBT.

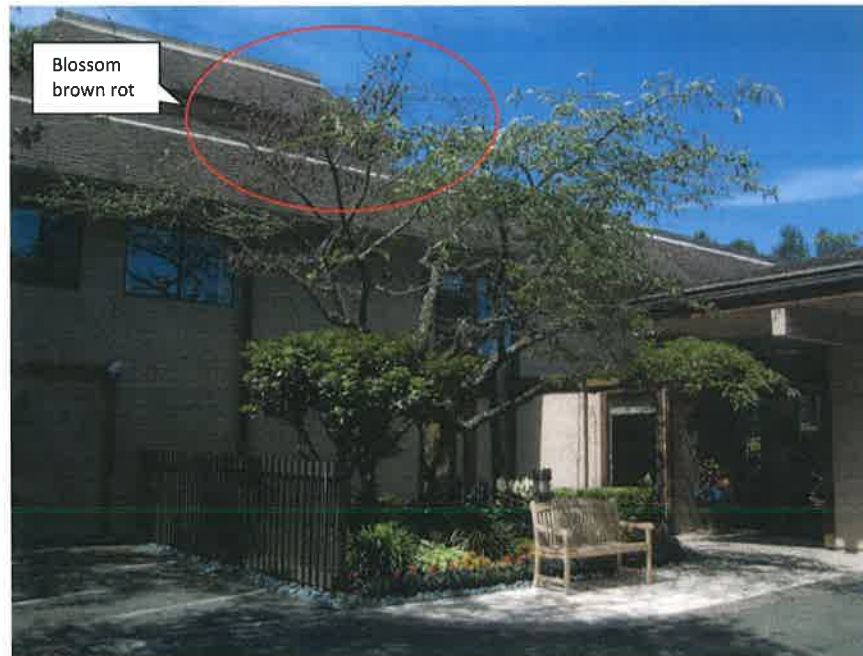
Tree 5 is a flowering cherry measuring 16.4 DSH, and showed significant dieback in the crown (see [Photo 3](#)). This tree is situated by the entrance way to the east, with one of the scaffold branches hanging over a bench in the front. I estimated this tree to have a 40% live crown ratio (LCR). Any branches that die on this tree will possess a potential hazard to the targets below, including sidewalk pedestrians, the fence, and the bench and its users. This tree had signs of blossom brown rot and CBT.

Photo 3- Tree 5 showing some dieback in the upper crown. Note area of dieback is above the branch that showed CBT evidence (Photo 2). Hanging foliage and flowers are signs of blossom brown rot.

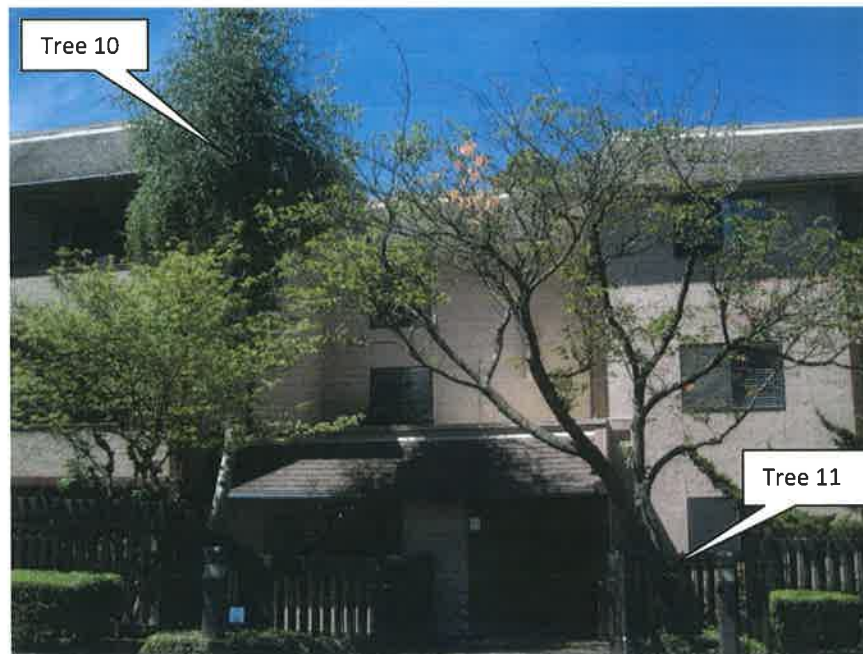
Tree 10 is a European birch, measuring 11.2 inches in diameter. This tree has a history of top cuts- resulting in a "lollipop" shape, which I have given a 'poor' structural form rating (see [Photo 4](#)).

Tree 11 is a flowering cherry measuring 10.1 DSH (using the single trunk formula). This tree also showed significant dieback in the crown (see [Photo 4](#)). This tree is located just west of the service entrance on the western wing of the building. I estimated this tree to have 30% LCR. Like **Tree 5**, Any branches that die on this tree will possess a potential hazard to the targets below using the service entrance. This tree had signs of blossom brown rot and CBT.

Photo 4- Note the overhanging branches of Tree 11, which are located over the service entrance. Dead twigs and old foliage/flowers hanging likely signs of blossom brown rot. Also note the 'lollipop' form of Tree 10.

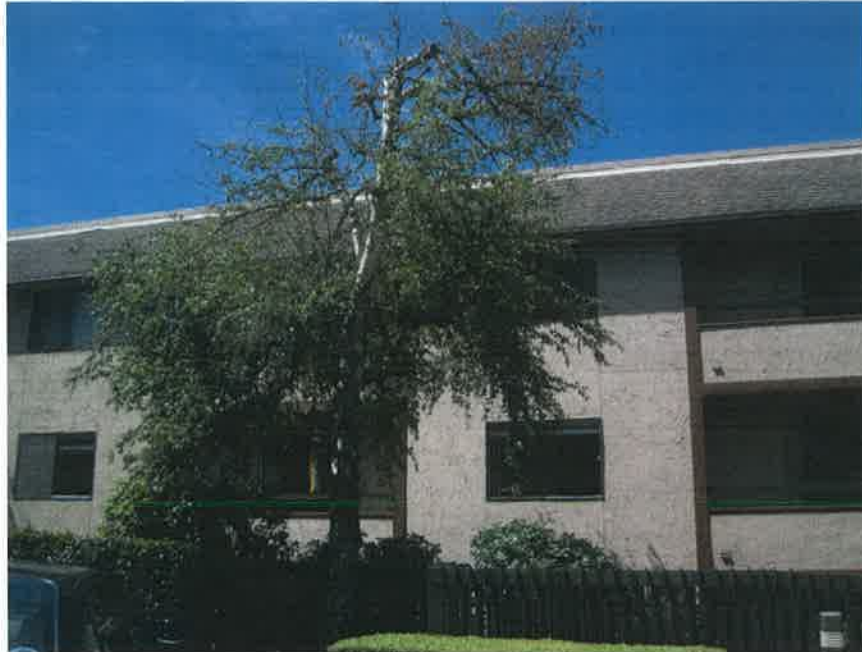
Tree 8 is a European birch, measuring 13.6 inches in diameter. I rated this tree with poor health and poor structure. The canopy of this tree is dying back, a typical symptom of BBB (see [Photo 5](#)). This tree was in the worst condition of all of the birches on site.

Photo 5- Tree 8. Note the top dieback, most likely due to bronze birch borer. Also note history of poor pruning history involving topping cuts, with no current top regrowth.

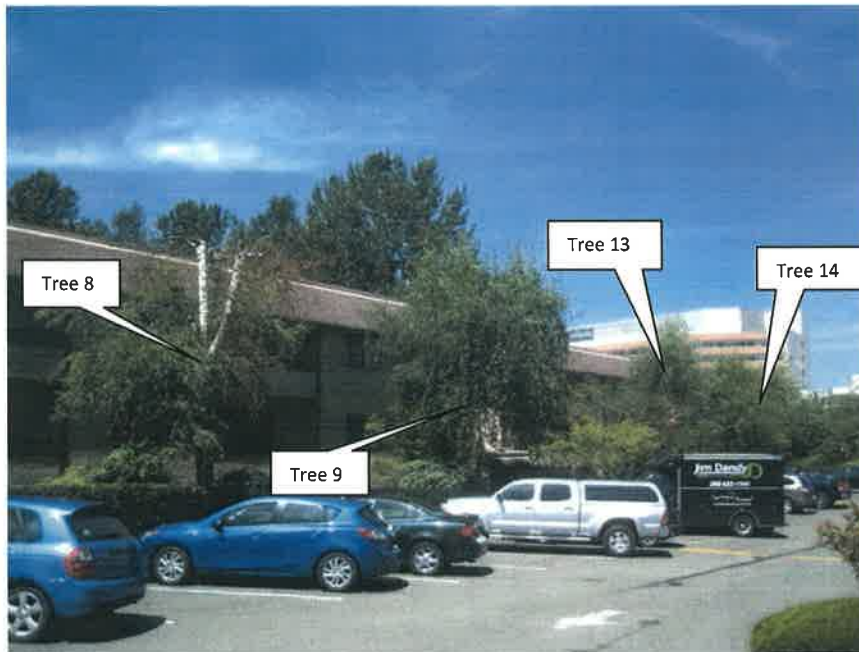
Tree 9 is a European birch, measuring 11.2 inches in diameter. This tree has a history of top cuts- resulting in a fair structural form (see [Photo 6](#)).

Tree 13 is a European birch, measuring 7.2 inches in diameter. This tree has a history of top cuts- resulting in a fair structural form (see [Photo 6](#)).

Tree 14 is a European birch, measuring 11.2 inches in diameter. This tree has a history of top cuts- resulting in "lollipop" form which I have rated as poor structural form (see [Photo 6](#)).

Photo 6- The row of birches as seen from the east. Note the extreme dieback of Tree 8, and the topped forms of Tree 9 and 13. (The brightness and contrast of this photo was adjusted so that the tree forms could be more visible)
